GB Check of the plug in the switching part of the CF500 control valve

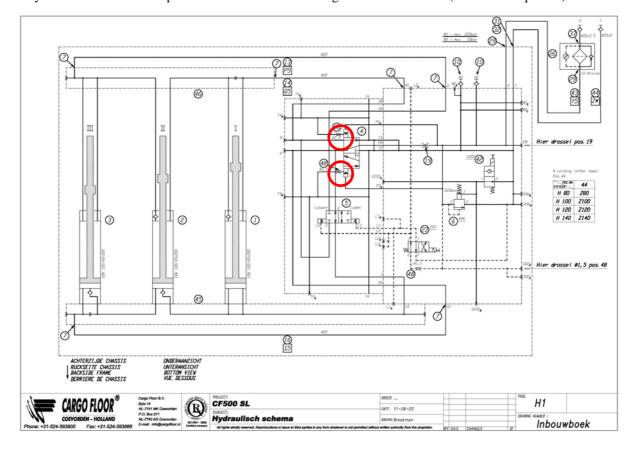
If the control valve switches with a delay, or not at all, despite that the thin piston rod 12 mm. has switched, the cause could be pollution in both return plugs or the plugs have moved. A clue for this problem is that all cylinders run until the end and then wait than a moment before going in the other direction. For a short period a pressure build up takes place without the cylinders moving.

In our hydraulic schedule this is position numbers 48 that belong to the control valve (circles in the picture).
